PROPERTY REPORT INSPECTION

Prepared For: Johnny Homebuyer
(Name of Client)

Concerning: 4325 Yourstreet, Somewhere, Texas 00000
(Address or Other Identification of Inspected Property)

By: Danny Young TREC # 10321 9/09/2009
(Name and License Number of Inspector) (Date)

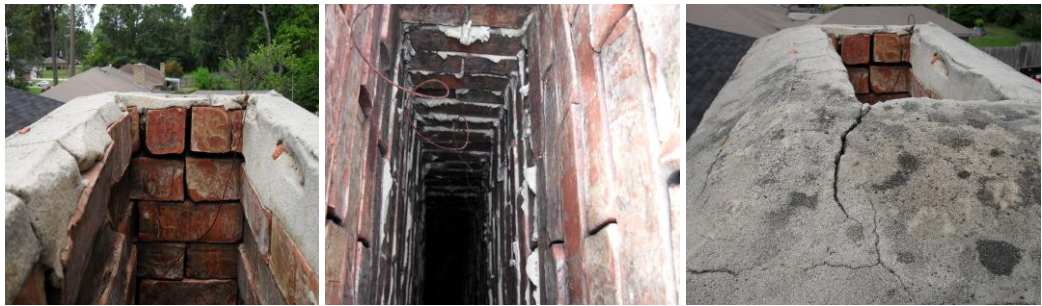
Comments: The fire place is located in the Den. It is wood burning with a gas starter. It is of a masonry type construction. The damper does not function. The flue is unlined and missing mortar and has loose bricks. The chimney cap is cracked. I would highly recommend that the fireplace be cleaned, repaired and re-evaluated before the first fire is started. This is a **safety** issue.

Missing mortar

Unlined flue

Cracked chimney cap
