# PROPERTY REPORT INSPECTION

**Prepared For:** Johnny Homebuyer  
(Name of Client)

**Concerning:** 4325 Yourstreet, Somewhere, Texas 00000  
(Address or Other Identification of Inspected Property)

**By:** Danny Young      TREC # 10321      9/09/2009  
(Name and License Number of Inspector)      (Date)

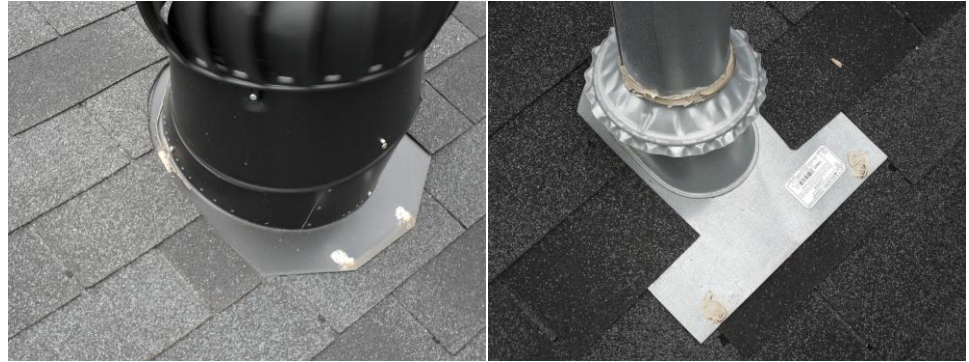
There are several exposed roofing nails on ridge, around vent flashing. These are potentially sources of leaks. This condition is very commonly found.

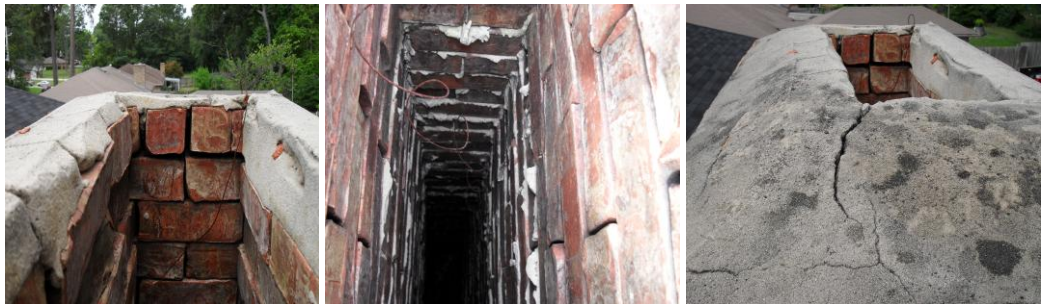
*Comments:* The fire place is located in the Den. It is wood burning with a gas starter. It is of a masonry type construction. The damper does not function. The flue is unlined and missing mortar and has loose bricks. The chimney cap is cracked. I would highly recommend that the fireplace be cleaned, repaired and re-evaluated before the first fire is started. This is a **safety** issue.

Missing mortar

Unlined flue

Cracked chimney cap

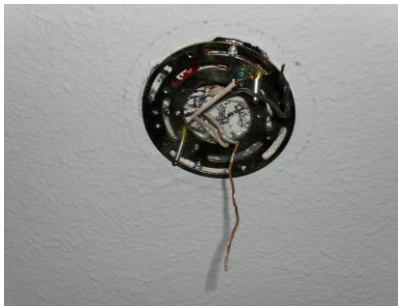
Kitchen Ceiling

*Comments:* The GFCI outlet in the Master Bath does not work. There is branch wiring within 6 foot of the attic access (attic floor level; actually within one foot). This is a safety issue as someone (I did) could touch the wire when reaching or going into the attic. There is one ceiling outlet in the kitchen which has exposed wired (not hot). I checked the main breaker panel and no breakers were thrown. This could be a safety issued and should be addressed.
